# Site Constraints Plan

# Building Constraints Plan

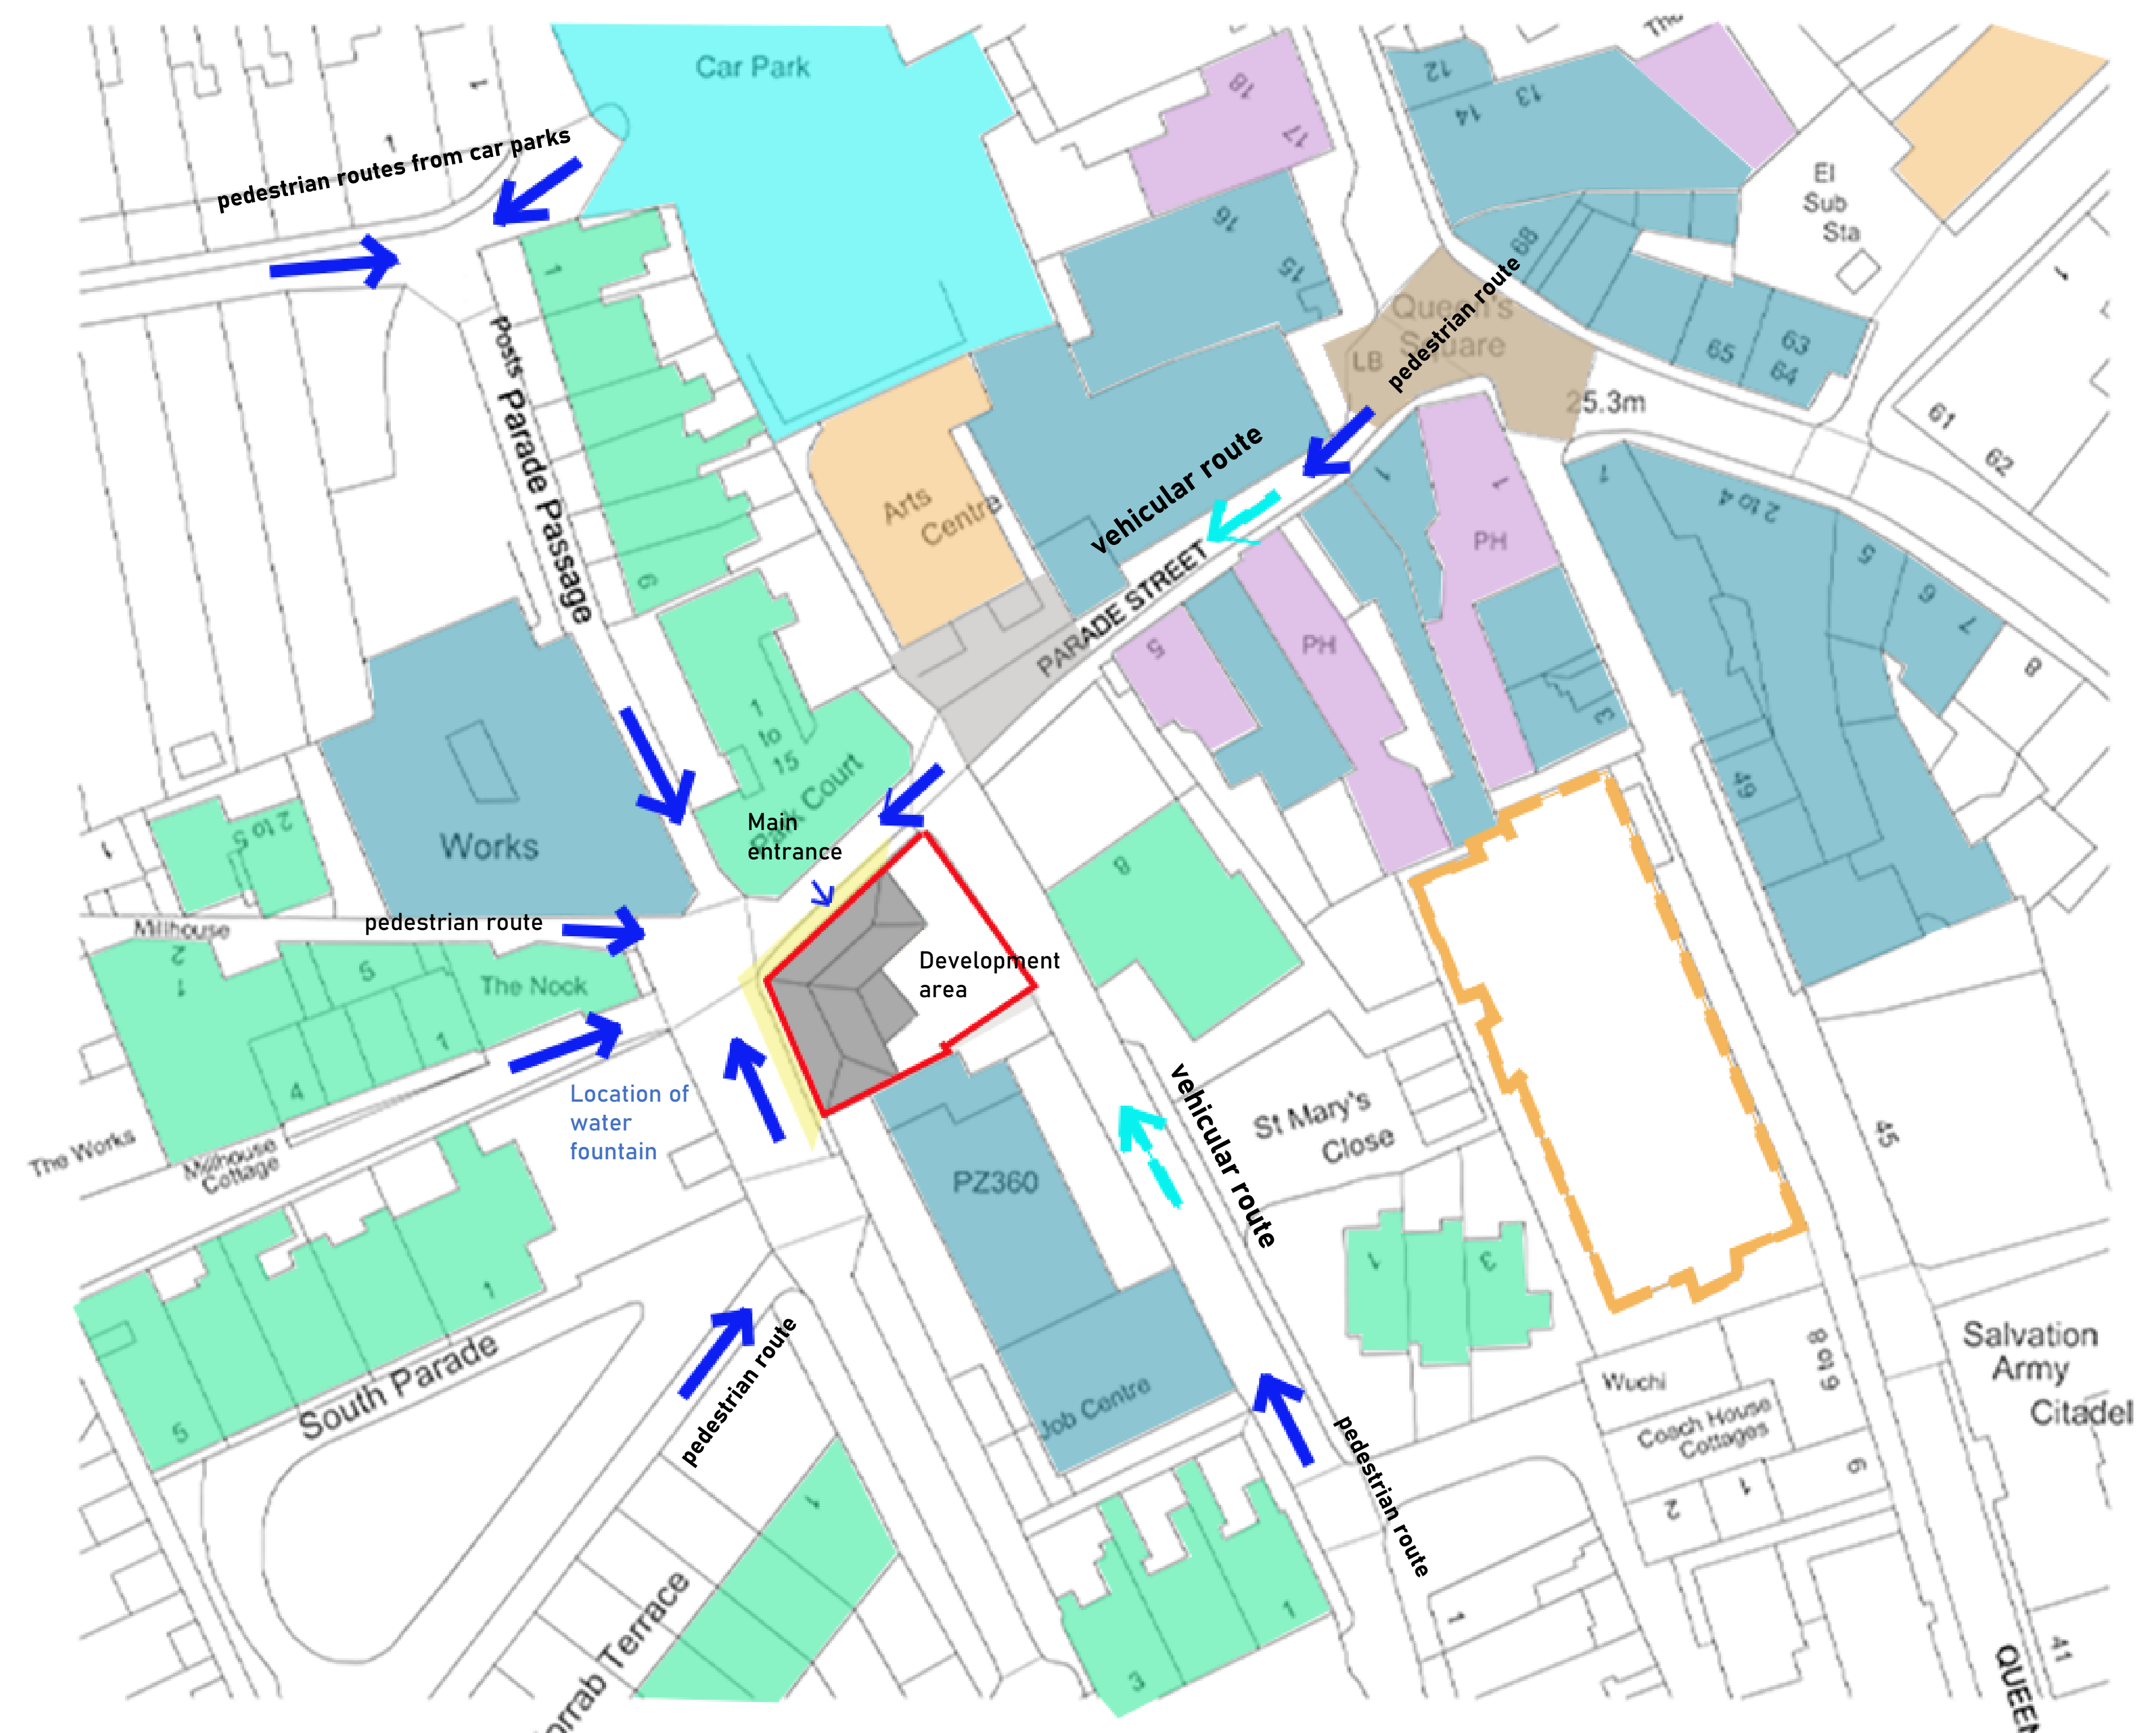
- Located in the heart of Penzance
- 10 Parade Street is Grade II listed with interesting architectural features both internally and externally
- Sits in a strategic & historic important junction where five pedestrian and cycle routes meet. Was once the location of the town's main water fountain

- Easy walking distance of several car parks – Green Market parking within a few 100 metres
- Currently some on-site parking with vehicular access along St Marys Terrace and Parade Street.

- Noise could be a concern due to proximity of Park Court and other residential properties
- Limited site for redevelopment (approx. area of 128m2, including car parking area)

- Important to maintain views towards and from the existing building
- No garden or ecology on site
- Surrounding architectural styles – principally early to late 19<sup>th</sup> Century with notable mid to late 20<sup>th</sup> Century buildings including PZ 360 and Park Court. Parade Street offers some interesting 'mews' style early 21<sup>st</sup> Century houses.

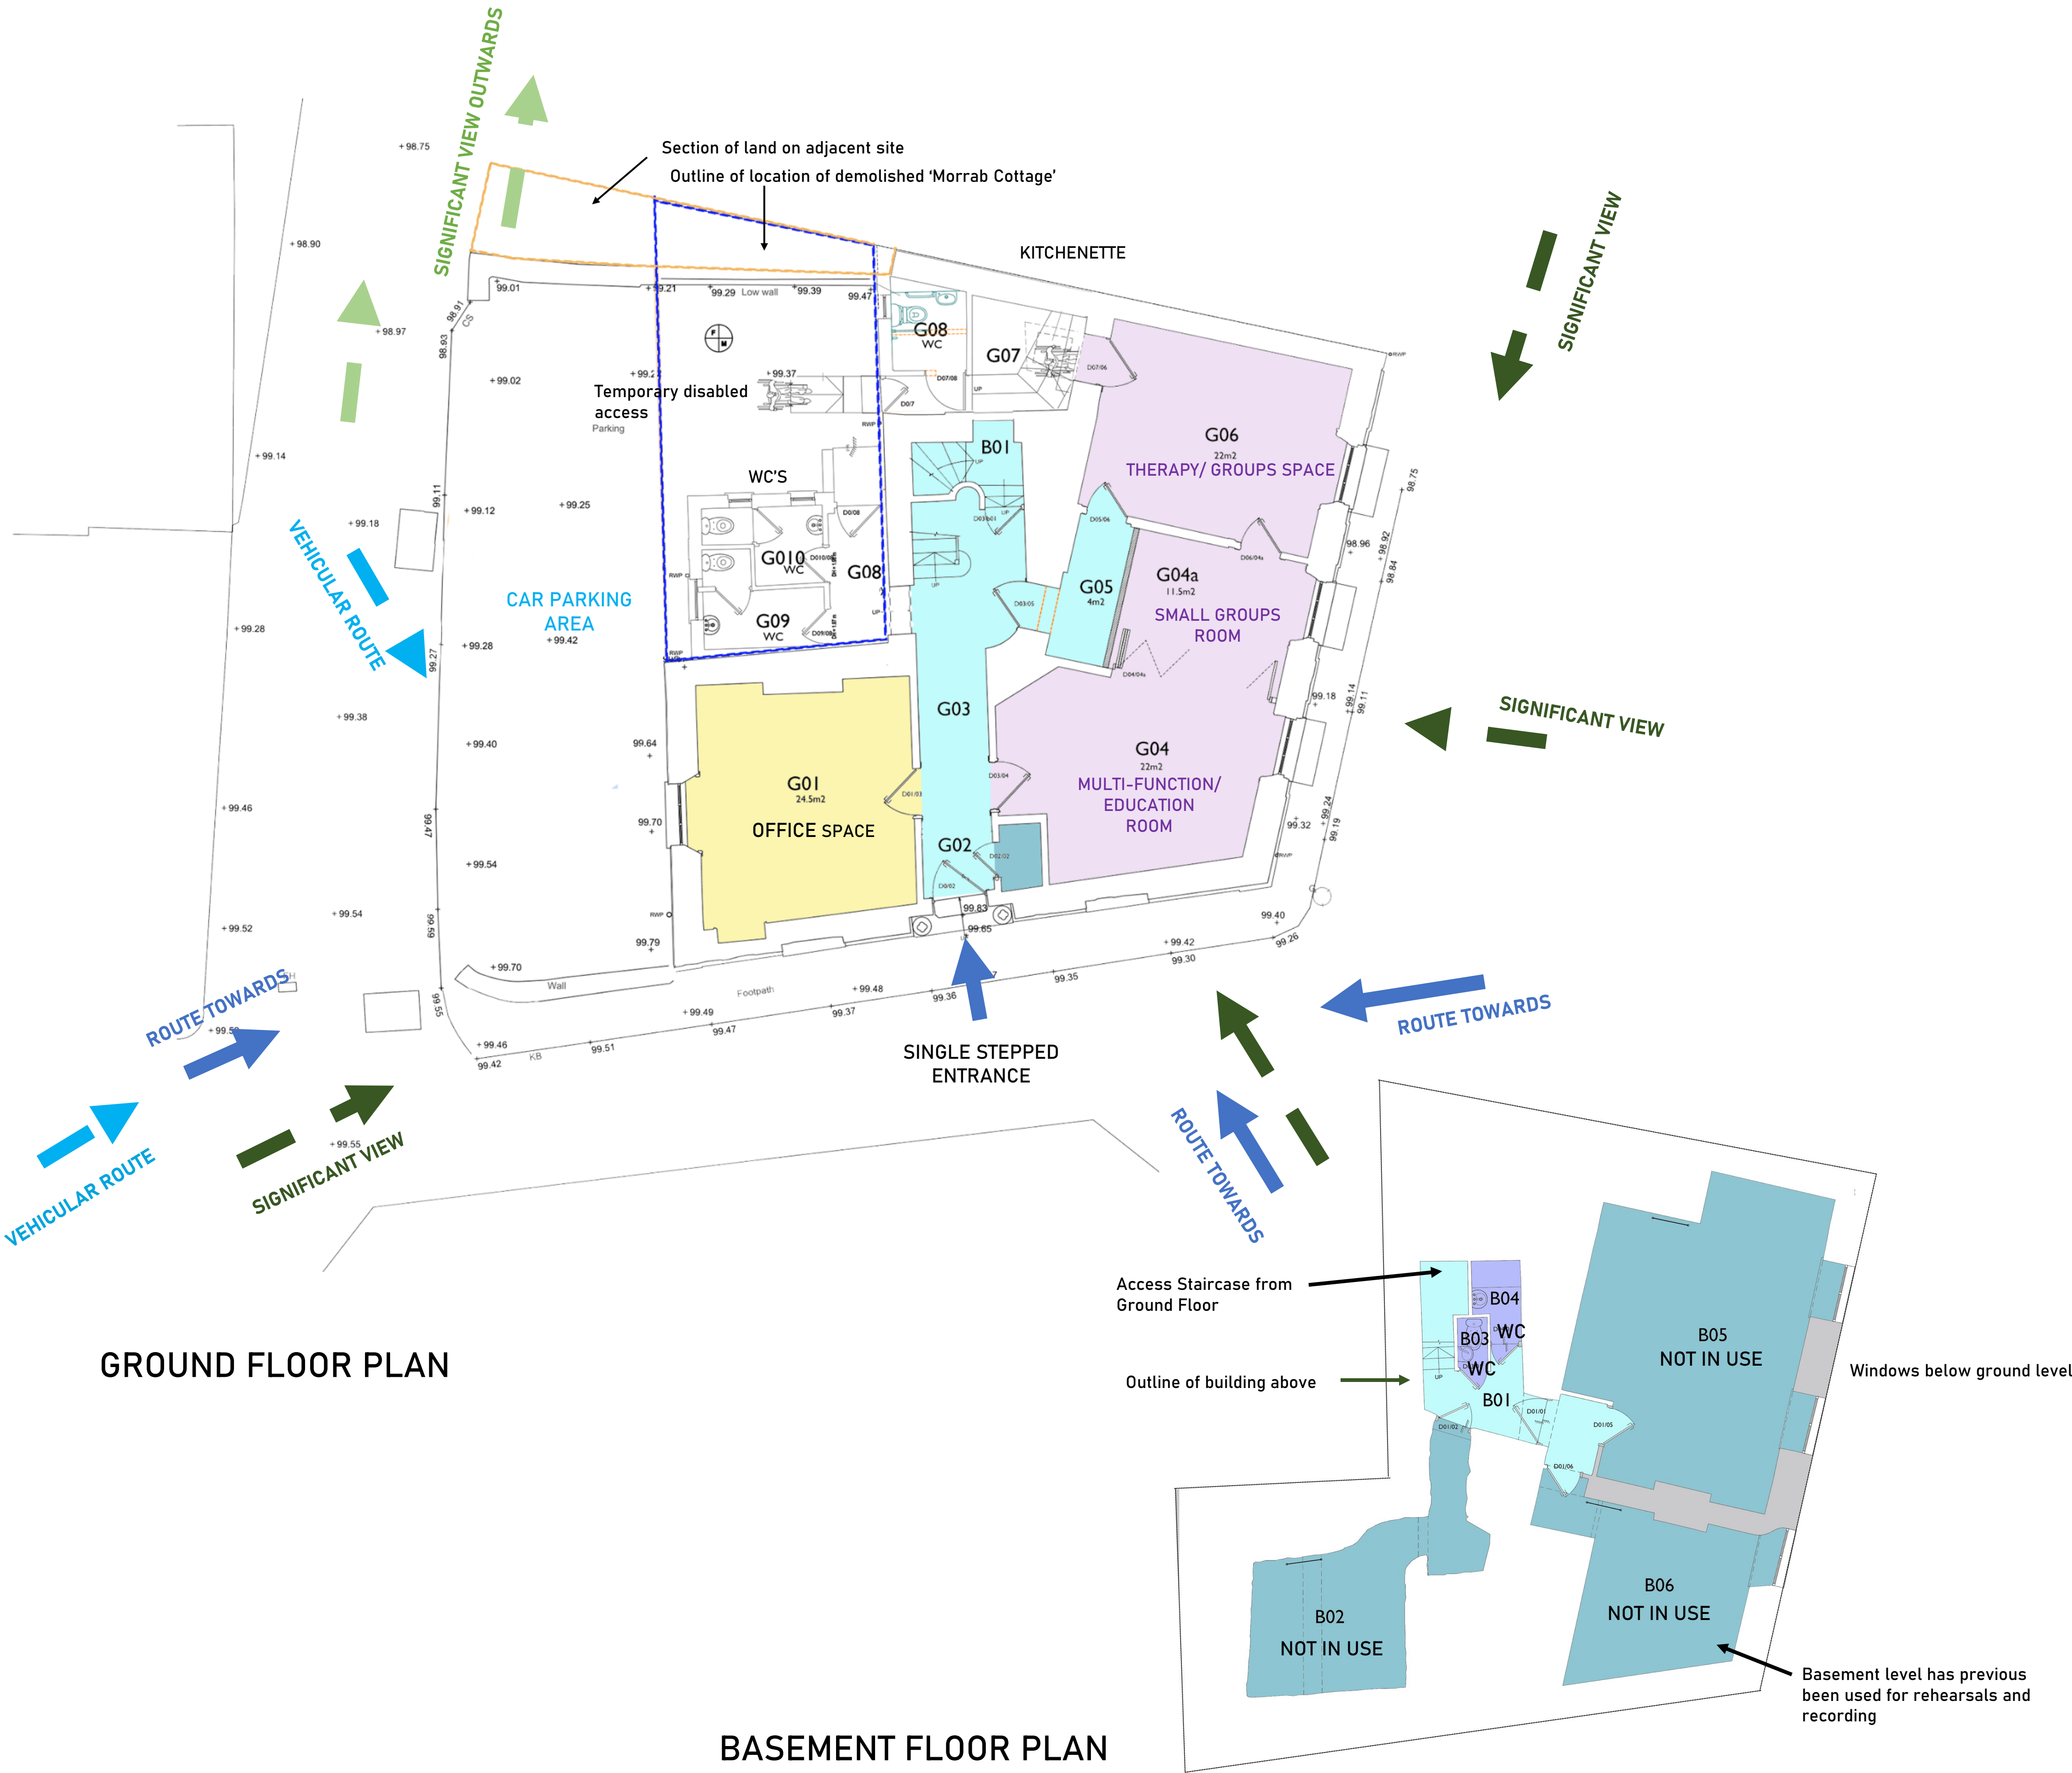
GROUND FLOOR PLAN

- Ground floor rooms have been let as office space. Need to be upgraded and modernised (acoustics, fire, ventilation)
- No access to first floor or basement other than via stairs. Access to basement particularly difficult to use.
- Building was extended mid 20<sup>th</sup> century to include two toilet blocks on the ground floor. These no longer meet modern requirements.
- No disabled or baby change facilities

- Access down existing staircase difficult.
- No lift access and no useable WC
- Good size rooms, have been previously used for music and recording
- No adequate waterproofing
- No appropriate means of escape
- Potential to explore space between existing rooms

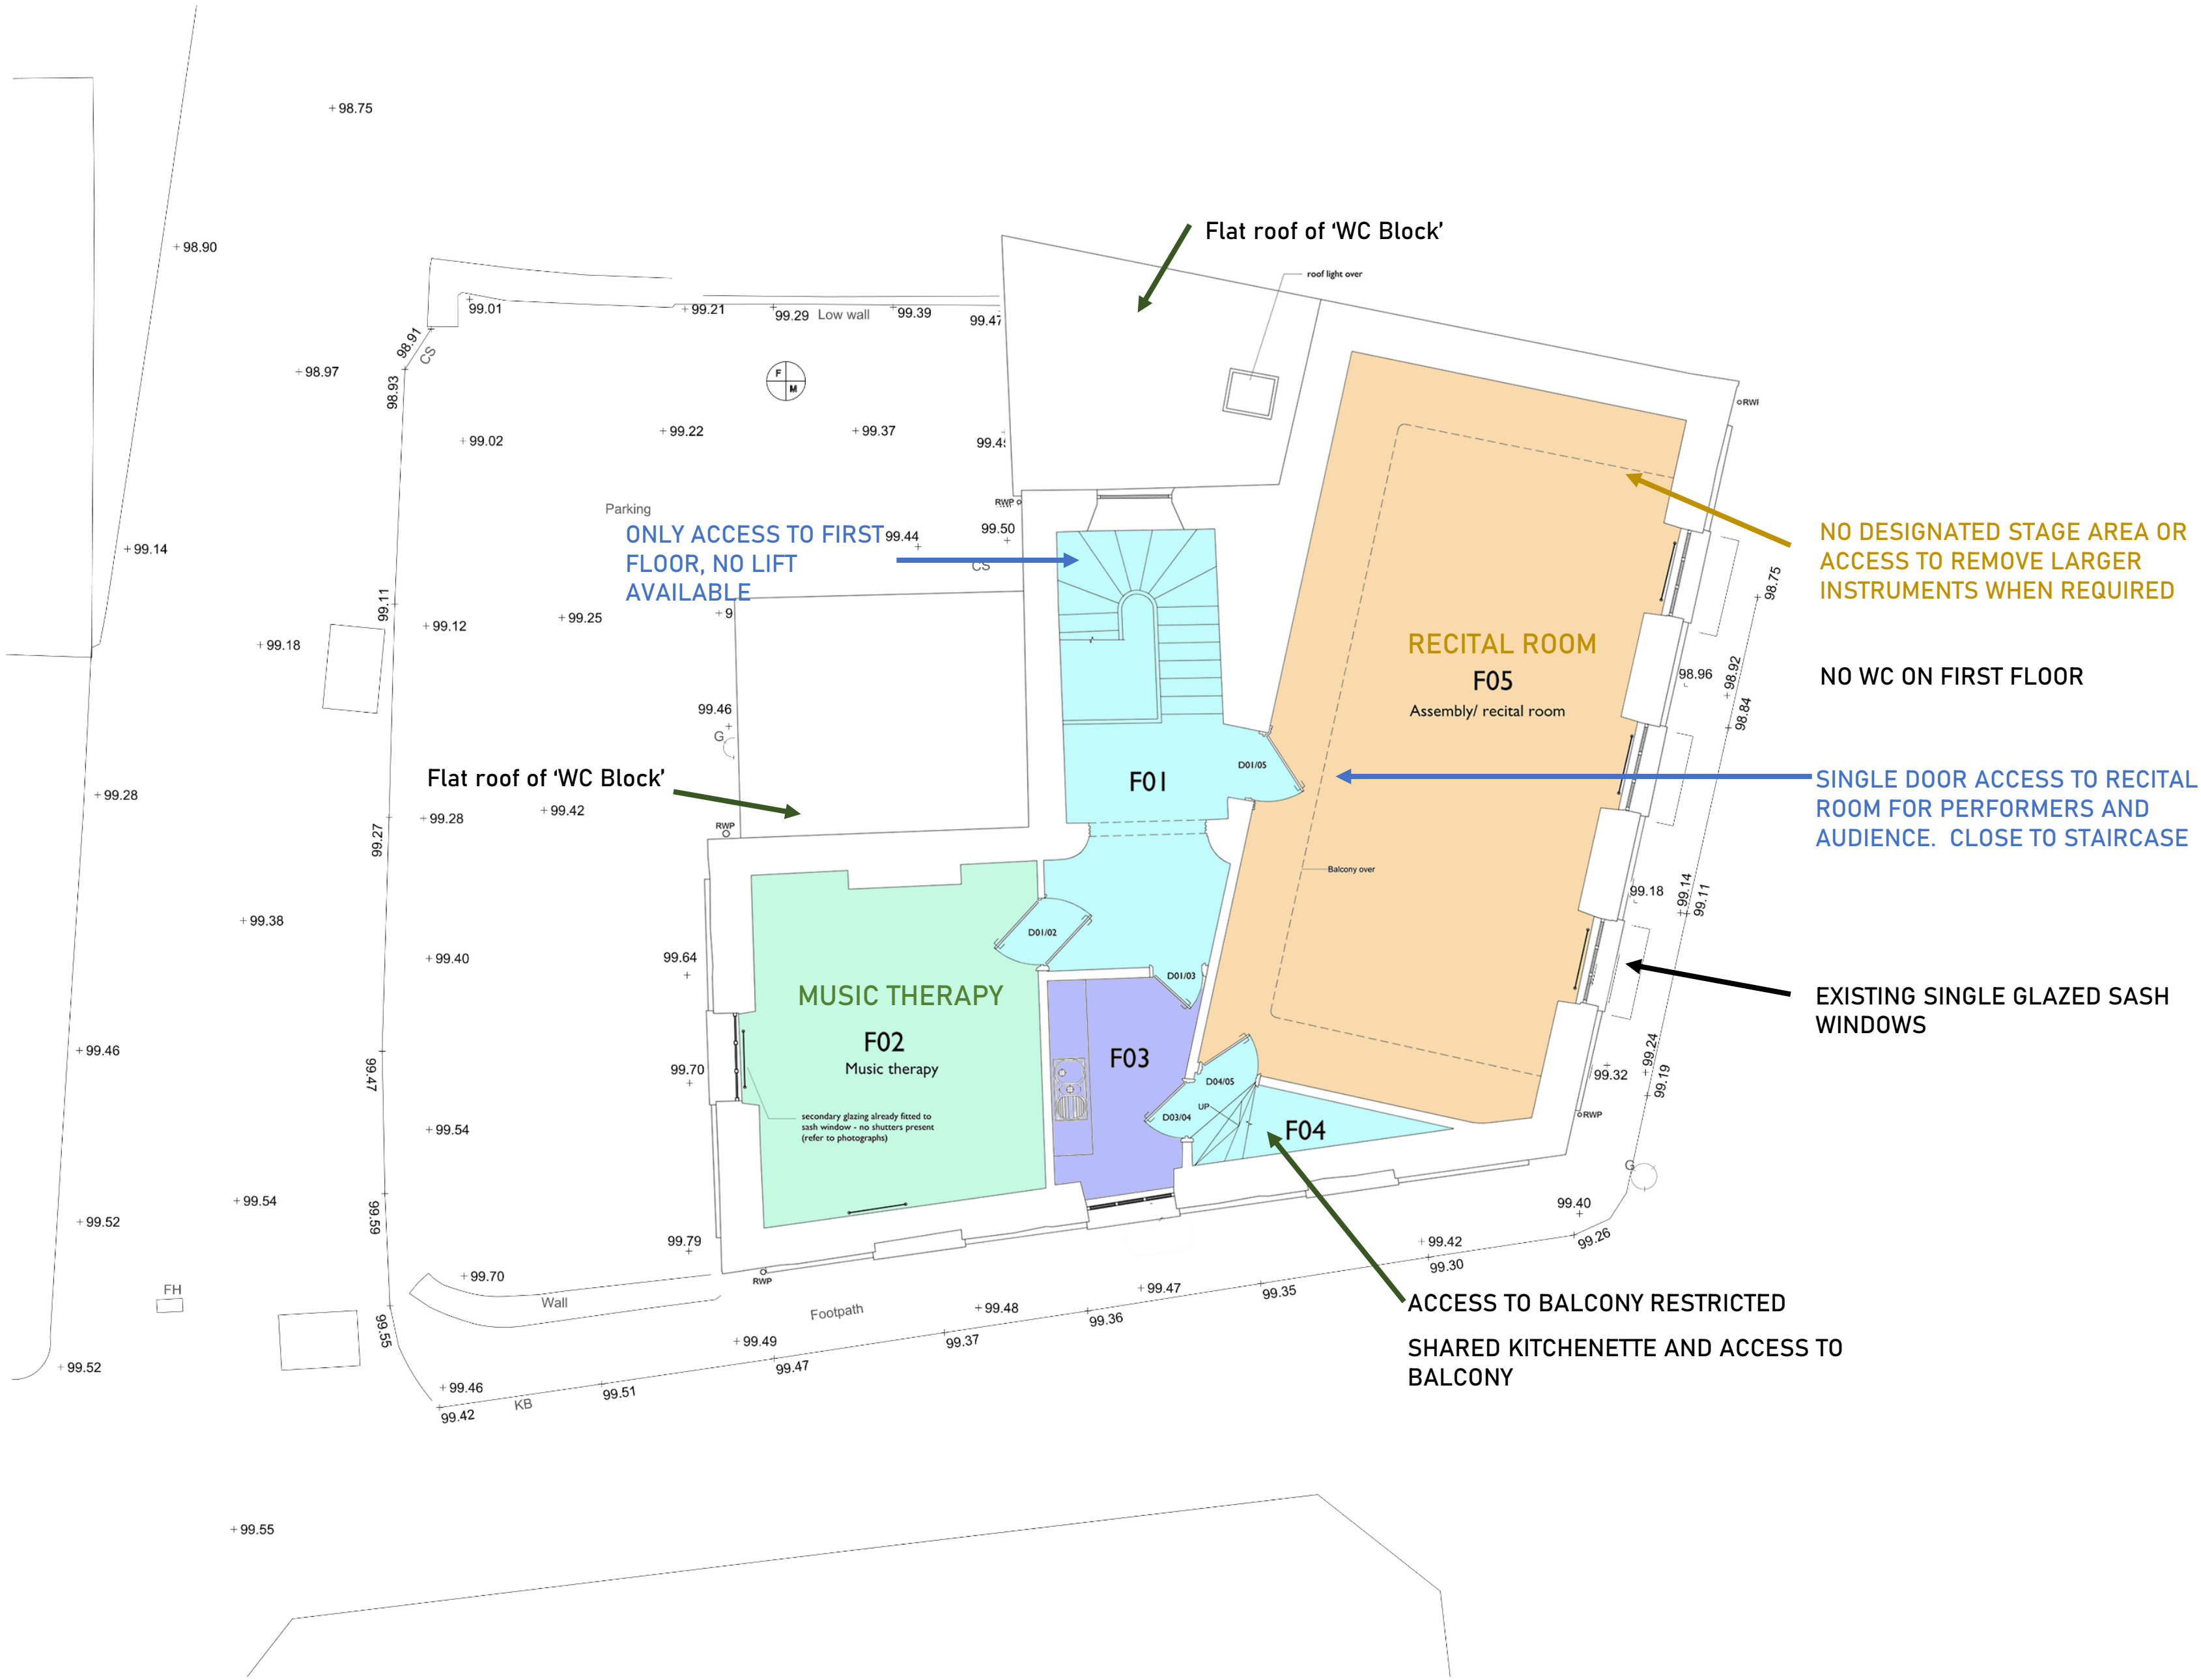
FIRST FLOOR PLAN & BALCONY

- No access to first floor other than via stairs, no lift.
- The Recital Room is in use for instrumental teaching, youth music ensembles, concerts given by young people and for online performances, but isn't capable of being used to full potential.

- Access to balcony limited via single small staircase
- Limited on number of audience members making it less viable (limited to 64)
- The Recital Room has excellent natural acoustics and an inviting atmosphere

- Music Therapy Room in Place and Works Well.
- Access to Recital Room is door directly at top of staircase – this creates a hazard and would create queuing within the vicinity of the stairs

- Limited acoustic provision – particularly to prevent noise spill to surrounding properties
- No WC provision on first floor
- Kitchenette area creates conflict with use of steps up to balcony

- Flooring to the first floor has been replaced with chipboard – new flooring system required – with acoustic properties.

- The structural condition of the balcony needs assessing
- Damage to the timber balustrade
- Could the balcony be extended to allow it to be better utilised for audiences?
- The building is now in a slightly sorry state, but not too far decayed to be rescued. Thankfully some original features have survived including the Library's original ceiling and rose, the balcony, doors and door surrounds and various other period architectural details.
